DEPARTMENT OF TRANSPORTATION

Contract #: 04-0120F4Cty: SF/ALA Rte: 80 PM: 13.2/13.9File #: 1.28**WELDING INSPECTION REPORT****Resident Engineer:**Pursell, Gary**Address:** 333 Burma Road**City:** Oakland, CA 94607**Report No:** WIR-015832**Date Inspected:** 26-Jul-2010**Project Name:** SAS Superstructure**OSM Arrival Time:** 700**Prime Contractor:** American Bridge/Fluor Enterprises, a JV**OSM Departure Time:** 1530**Contractor:** American Bridge/Fluor Enterprises, a JV**Location:** Jobsite**CWI Name:** See below**CWI Present:** Yes No**Inspected CWI report:** Yes No N/A**Rod Oven in Use:** Yes No N/A**Electrode to specification:** Yes No N/A**Weld Procedures Followed:** Yes No N/A**Qualified Welders:** Yes No N/A**Verified Joint Fit-up:** Yes No N/A**Approved Drawings:** Yes No N/A**Approved WPS:** Yes No N/A**Delayed / Cancelled:** Yes No N/A**Bridge No:** 34-0006**Component:** SAS OBG**Summary of Items Observed:**

WELDING INSPECTION REPORT

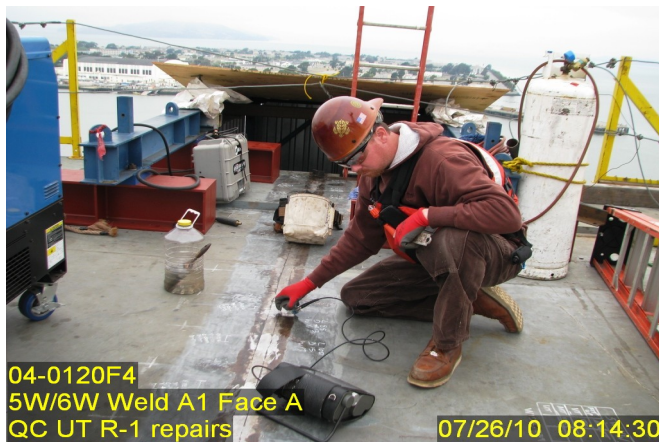
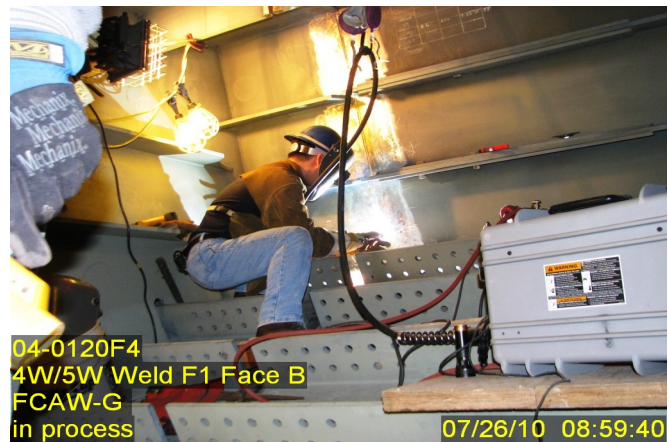
The QAI periodically observed the in process welding of the OBG Field Splice 4W/5W weld ID: F1 Face B per the Flux Cored Welding (FCAW-G) process in the 3G (vertical) position by approved AB/F welding personnel Hua Quiang Hwang (ID 2930). See photo below. The SE QC Inspector Tom Pasqualone was present to monitor the progress and verify that the welding parameters were within the limits established by the approved welding Procedure Specification (WPS) identified as ABF-WPS-D1.5-3110-3. The QAI observed that QC Mr. Pasqualone obtained the following welding parameters: welding Amps = 225, welding Volts = 21. Welding of the fill and cover passes was completed and work at this location appeared to be in general compliance with contract documents.
